**Anais do 50º Congresso Brasileiro do Concreto  
CBC2008 - RCC Symposium**  
Setembro / 2008  
ISBN  
@ 2008 - IBRACON

## **Roller-compacted Concrete for Dam Safety Modifications**

Roller-compacted concrete (RCC) is used throughout the world for new dam construction. In the United States, RCC is also used extensively for modifying dams with safety deficiencies including stability buttresses for concrete dams, overtopping protection for both concrete and embankment dams, and for constructing spillways. Rapidly placing RCC has an advantage for dam modifications which may only have a limited time to complete construction before placing the structures back in service. The Bureau of Reclamation has used RCC for several unique dam safety modifications. The Portland Cement Association (PCA) has been leading the design and construction industry by promoting the use of RCC in embankment dam overtopping protection since 1985. This paper will discuss the use of RCC for dam modifications including design and construction considerations for RCC construction and case histories of RCC dam safety modifications. *Keywords: RCC, Dam Safety Modification, Concrete Dam, Spillways, Overtopping Protec

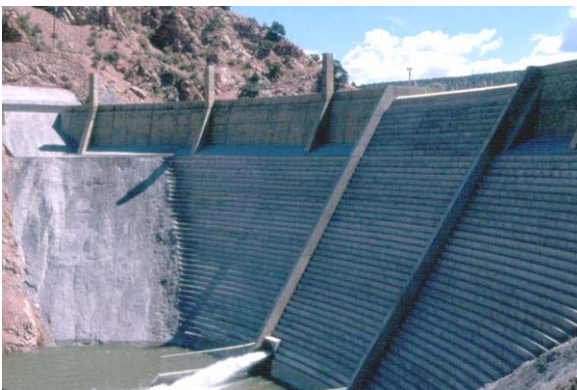
Figure 1 - RCC buttress with stepped facing for Santa Cruz Dam (Bureau of Reclamation, 1990).

The requirements for compressive strength were based on the MCE loading condition. The design requirements for the RCC were a compressive strength of 21 MPa at 1 year, cohesion between new and old concrete of 345 KPa at 1 year, and freeze-thaw durability to withstand no less than 500 cycles. Santa Cruz Dam modification was the first to use an air-entraining admixture to improve the freeze-thaw durability of the RCC. RCC was mixed in a continuous weigh batching “pugmill” and was delivered to the placement location by a 115 m conveyor. Conventional concrete was used for the exposed downstream face and at the RCC/foundation rock contact. During construction, the lift placement rate was an average of four lifts per day. A total of 29,260 m<sup>3</sup> of RCC was placed. The unique gallery construction for the dam was accomplished by a shotcrete overlay on an inflatable “Air-o-Form.” This forming system worked very well in this application because of the uneven and curved surface of the downstream face of the existing dam (Vaskov, 1990).

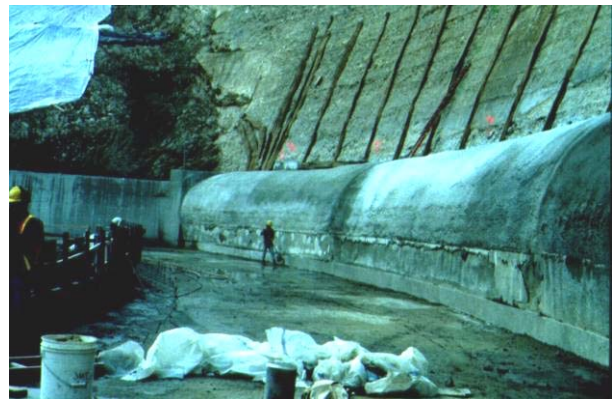
Figure 2 – Shotcrete gallery and buttress contact drains for Santa Cruz Dam (Bureau of Reclamation, 1990).

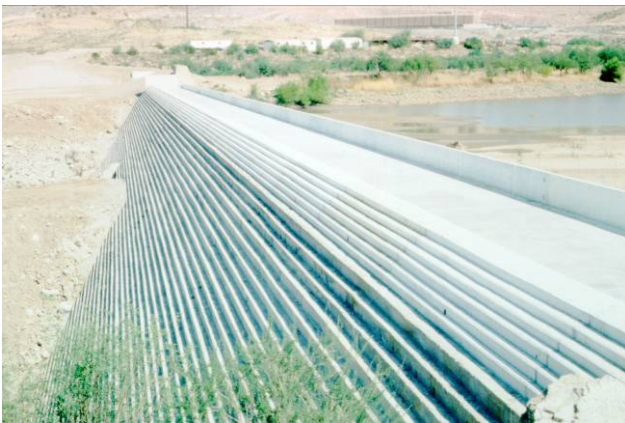
Figure 3 – All RCC stepped spillway at Camp Dyer Diversion Dam spillway after completion (Bureau of Reclamation, 1992).

District. Stability analyses of the maximum section of the existing gravity dam indicated that a stability buttress was needed to increase the dead load and sliding resistance of the modified structure. A buttress width of 6 m was selected to accommodate two lanes of construction traffic on the RCC. The 0.8:1 horizontal to vertical (H:V) downstream face of the overflow crest and RCC buttress was stepped for optimum energy dissipation of the maximum 0.6 m deep overtopping flow.

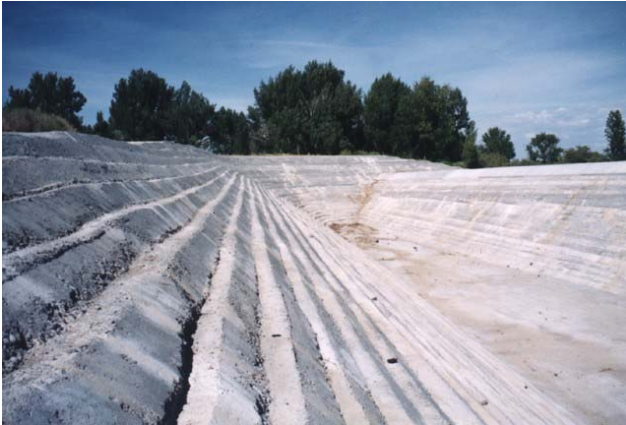
Figure 5 – RCC side channel spillway at Cold Springs Dam Spillway Modification (Bureau of Reclamation, 1996).

A modification design was completed in 1994 and construction was completed in 1996. The spillway modifications included an almost complete replacement of the original structure with a wider, more stable RCC structure (Reclamation, 1994). The design discharge for the new side-channel spillway was 800 m<sup>3</sup>/s. High velocities (up to 14 m/s) and the potential for high uplift pressures made the massive RCC construction more desirable (Reclamation, 1996). The 0.9 m thick RCC invert slab provides mass for increased stability. The 1.5H:1V side slopes, and 3 m wide lifts were configured to accommodate construction equipment, resulting in an RCC thickness of approximately 1.5 m normal to the slope. An underdrain system beneath the crest, side channel, and discharge chute increases stability by relieving uplift pressures and reducing the potential for piping of foundation materials. The underdrain system consists of transverse perforated collector drains beneath the crest, and longitudinal perforated drains beneath the side channel and chute slabs. The 150 mm HDPE transverse drains are spaced about 30 m along the centerline of the chute to reduce the cross sectional area of the 0.9 m thick RCC invert slab sufficiently to induce cracking. Since the spillway was a side channel design, the upstream end was closed by wrap-around RCC. The original design was a

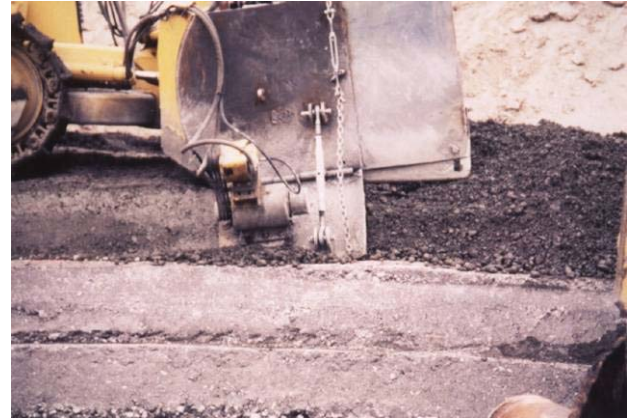
Figure 6 - Vibrating plate compactor for RCC edge at Cold Springs Dam Spillway Modification. (Bureau of Reclamation, 1996).

The mix was designed to provide a compressive strength of 28 MPa at 28 days for immediate operational use, freeze-thaw durability, and erosion resistance. The 13,700 m<sup>3</sup> of RCC was placed in nearly horizontal layers of approximately 300 mm thickness having a maximum sloping grade of 2.5 percent. The RCC was batched in a continuous weigh-batch plant, mixed in a “pugmill”, and discharged to a holding hopper prior to loading in end dump trucks. RCC was hauled to the site in the dump trucks, where it was deposited in a moveable holding bin. A backhoe picked up the RCC and deposited it in front of a dozer. It was spread in uniform layers by the dozer and compacted by the roller. The 3 m wide, 1½H:1V chute side slopes were unformed. However, the dozer blade was retrofitted with side extensions that were in front of and normal to the face of the blade and a tamping plate to vibrate the RCC during the spreading process. As material was spread in front of and below the bottom of the blade, the plate confined and compacted the material along the exposed edge of the chute. These sloping faces were fairly well compacted, achieving about 95 percent of the maximum achievable wet density.

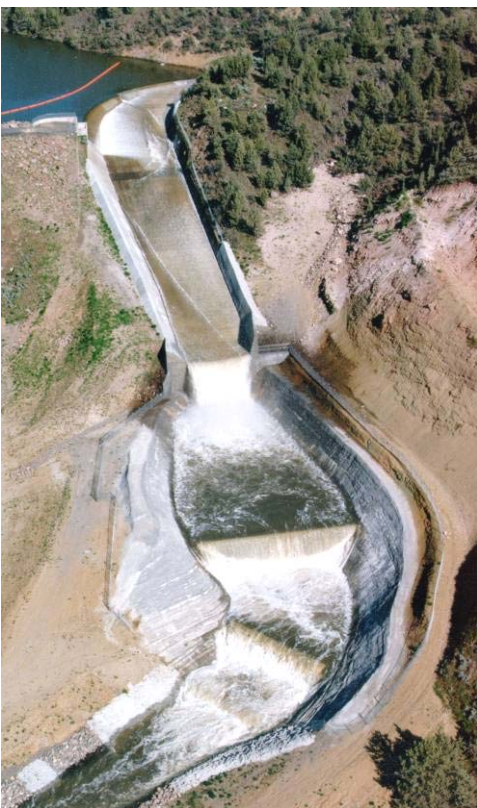
Figure 7 – Ochoco Dam Spillway Modification stilling basin plunge pool spilling during flood of record (Bureau of Reclamation, 1997).

Several challenges existed at the site including non-uniform foundation conditions on rock and compacted soil, a steep hillside resulting in a 0.8H:1V left side slope and 1.5H:1V on the right side, and an underlying artesian aquifer limiting the depth of excavation and resulting tailwater depth. Drains were placed under the structure to relieve uplift pressure caused by potentially high dynamic flow conditions and to pick up seepage through any future cracking of the RCC. About 14,400 m<sup>3</sup> of RCC were placed over a 3 week period on a 24-hour basis (Reclamation, 1996).

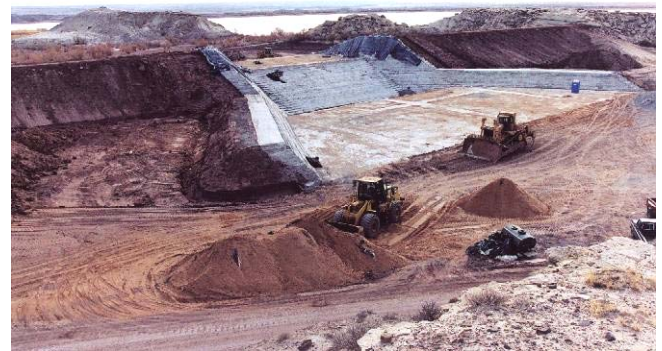
Figure 8. Many Farms Dam Spillway Modification (Bureau of Reclamation, 2000).

The spillway would experience flow velocities up to 12 m/s during the PMF (Reclamation, 2001). The RCC forming the downstream stilling basin and apron is installed on filter material, which ties into the dike toe drain. A geotextile was provided beneath this RCC to prevent mixing of the filter zone and RCC as it was spread and compacted. The spillway apron and side slopes also had 300 mm wide flat drains to supplement the filter material and toe drain to reduce uplift pressures beneath the stilling basin slab.

The contractor was allowed to compact the exposed RCC face to any slope between vertical and 1H:1V. Saw cuts were used to control cracking along the spillway centerline. The design strength of the RCC was to 28 MPa at 90 days to increase the durability of the RCC. The contractor erected a concrete batch plant immediately downstream of the spillway apron capable of batching and mixing both conventional and RCC. Conventional concrete was used at foundation contacts and bonding mortar was applied on lifts that are one day old or older prior to spreading subsequent lifts. RCC was batched directly into end dump truck and transported and off loaded into a holding bin feeding a telescoping conveyor. A combination of four vibratory passes followed by two static passes was used to obtain the required compaction for the majority of RCC placements. The contractor utilized an excavator with a shop-fabricated vibrating plate to accomplish the edge compaction. The vibrating plate was constructed with a 45-degree angle, which allowed for compaction of the outside 300 mm of the top surface of the lift and the outside sloping face (Reclamation, 2001).

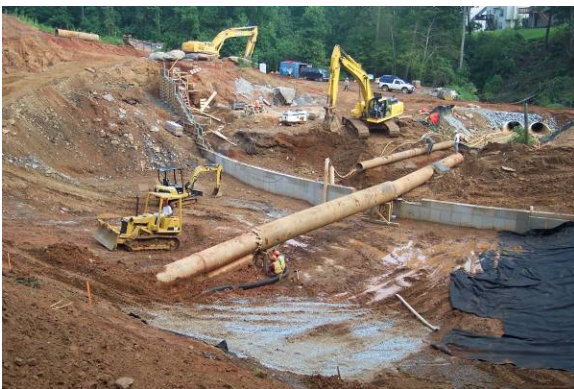
Figure 8 - Foundation preparation and construction of conventional concrete downstream cutoff wall at Y-14 (Golder 2003)

When the structure was found not in compliance with applicable dam safety regulations, analyses identified that the most cost effective solution was construction of an RCC spillway overtopping the existing dam and abandoning the existing earthen auxiliary spillway. Due to site constraints, Golder Associates, Inc. (Golder) designed an arc shaped chute spillway with an ogee weir to minimize convergence impacts and provide favorable hydraulic performance. The RCC spillway steps were constructed by forming the front edge of the 30-cm high, 3-m wide steps as shown in figures 8 to 11.

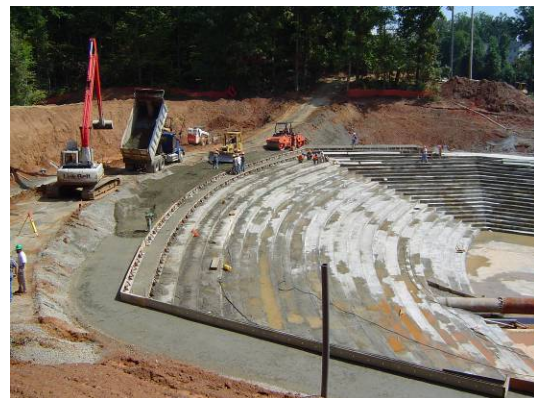
Figure 9 - Equipment used to haul, place, spread and compact the RCC (Golder 2003).

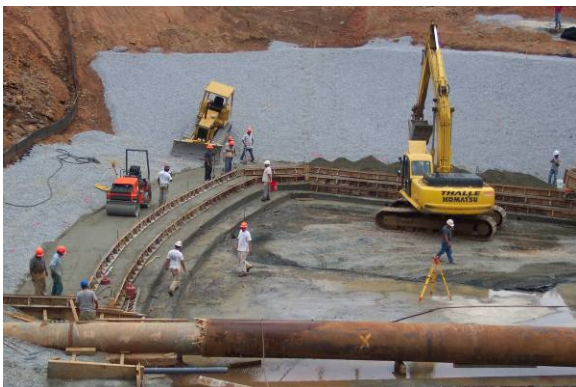
Figure 10 - Construction filter/drainage layer and first few lifts of RCC with formed edges (Golder 2003).

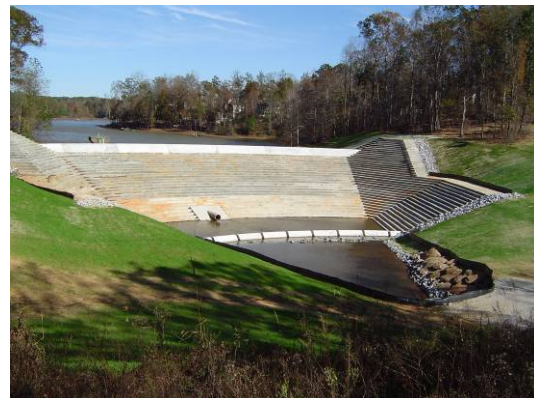
Figure 11 - Completed RCC Spillway with reinforced conventional concrete Ogee Crest (Golder 2003).

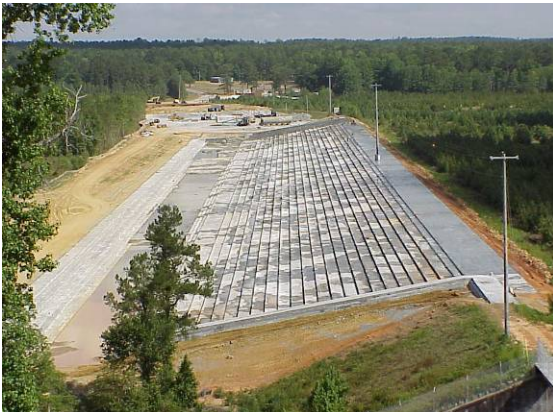
Figure 12 - RCC spillway and collection channel at Tholocco Lake Dam (USACE, 2000)

Another example is Lake Tholocco Dam located in south Alabama and owned by the US Army Corps of Engineers (USACE). Constructed in the 1930s, this dam is an earth embankment creating a 275-hectare lake for training of military personnel and for recreational activities. The dam has 15.2 m reinforced concrete service spillway with a fixed ogee crest. The original construction included an earthen emergency spillway, which operated regularly causing severe erosion. During July 1-4, 1994, tropical Storm Alberto failed the earthen spillway and the reservoir remained empty for six years. In 2000, the USACE elected to re-build the failed dam and install an RCC auxiliary spillway with a collection channel in the embankment adjacent to the reinforced concrete service spillway shown in Figure 12. The design called for a 472 m-long by 11m-high stepped spillway

constructed with 30 cm thick RCC steps. The crest elevation was set to discharge water from rainfall events once every one to two years, and the design maximum overflow depth was 2.0 m. The RCC lifts varied in width from 2.4 to 3.7 m. The spillway chute was designed at 6H:1V and the downstream side of the collection channel was 3H:1V. The spillway has been overtopped a few times as shown in Figure 13 with a maximum overflow depth of 0.9 m. On-site personnel report that the spillway has been performing well with no signs of distress..

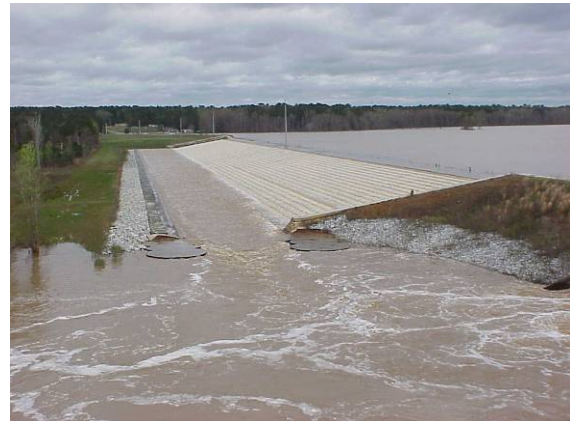
Figure 13 - RCC spillway during an overtopping event (USACE, 2005).
