56° Congresso Brasileiro do Concreto

## Management of aging Infrastructure Challenges for Owners and Operators

Jürgen Krieger, Federal Highway Research Institute (BASt), Bergisch Gladbach, Germany

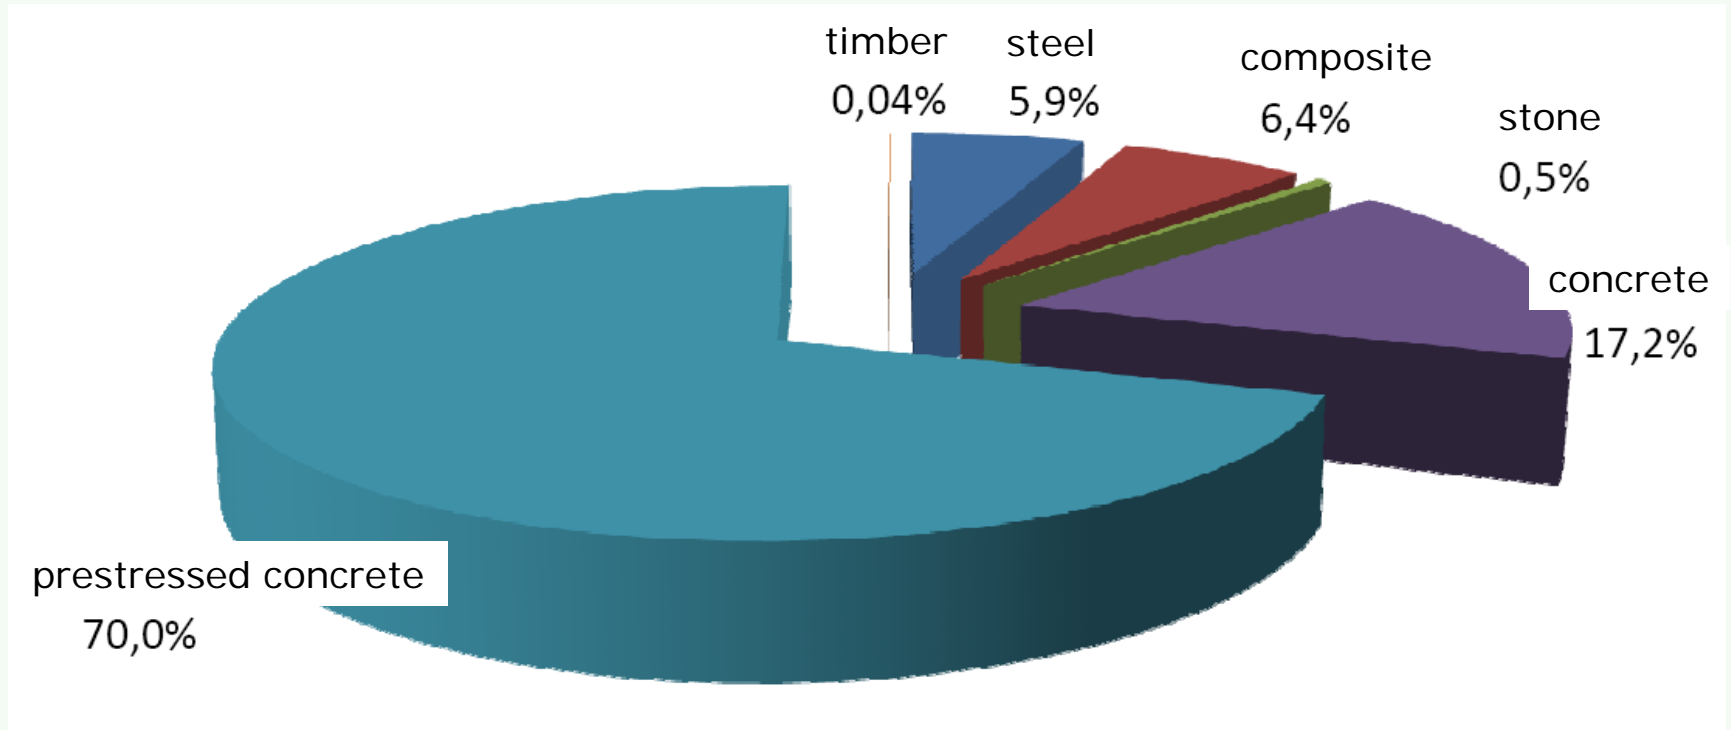
## Bridges on Federal Roads

<b>Federal Roads</b>	
<b>Bridges:</b>	<b>40.000</b>
<b>Tunnels:</b>	<b>240</b>

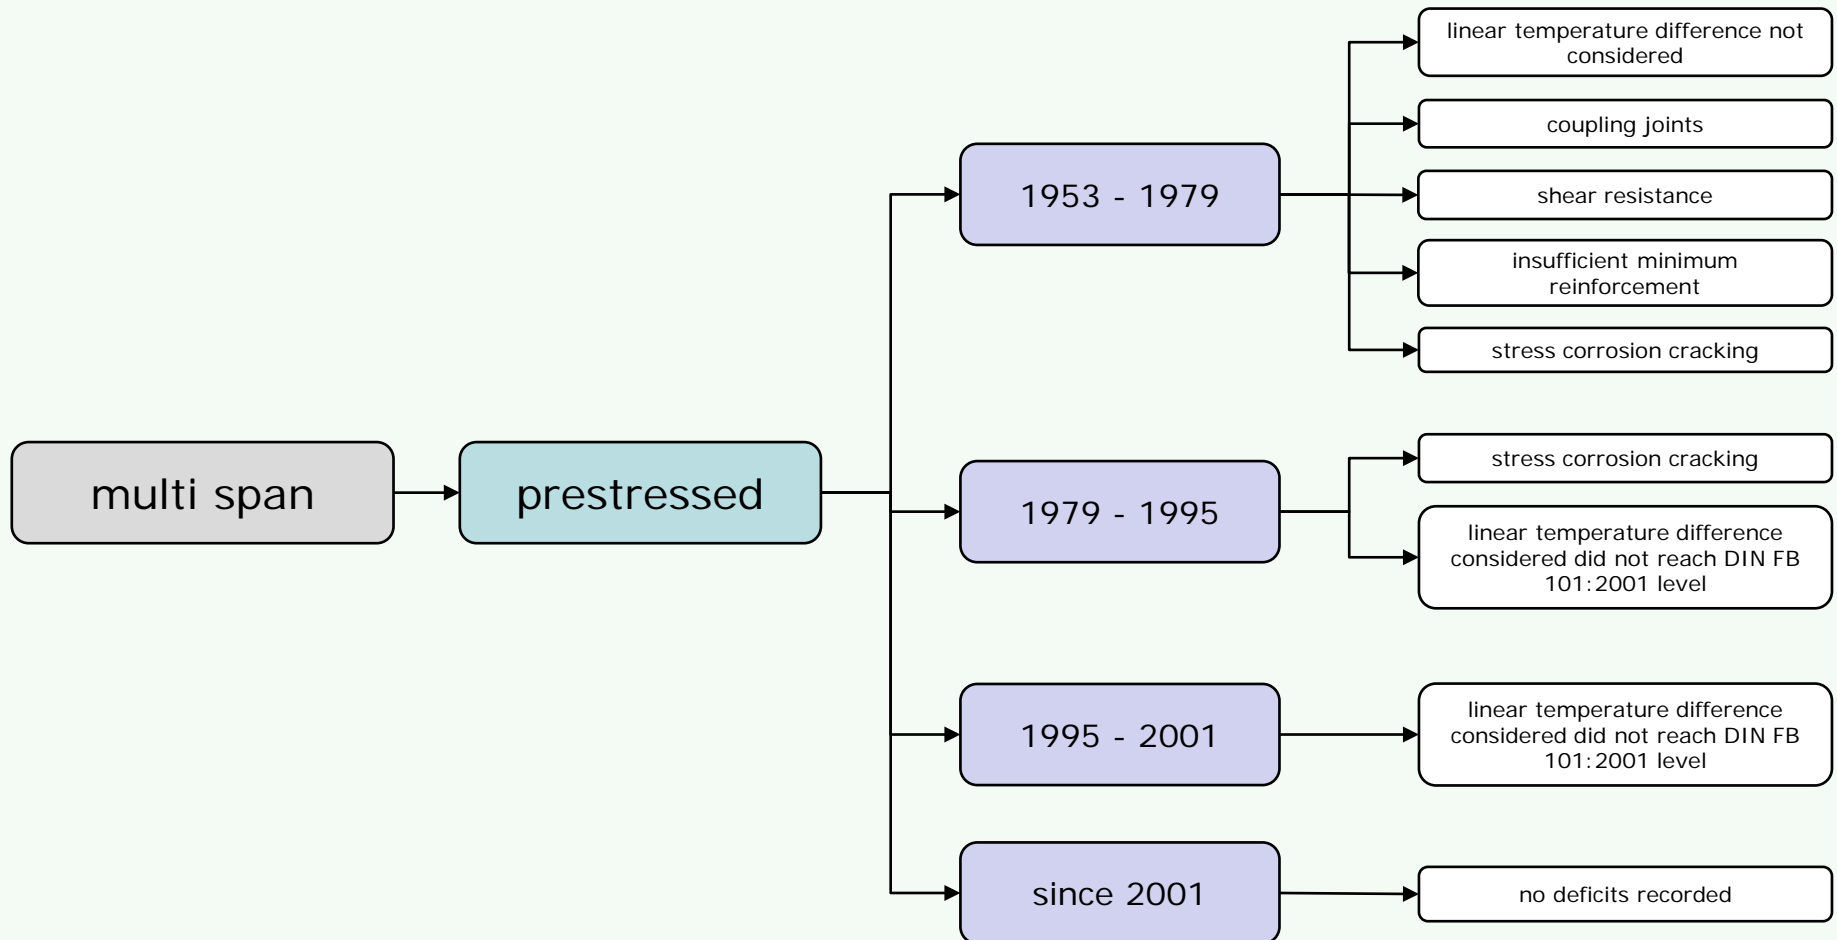
# Possible Deficits of Bridges

Construction

Deficits

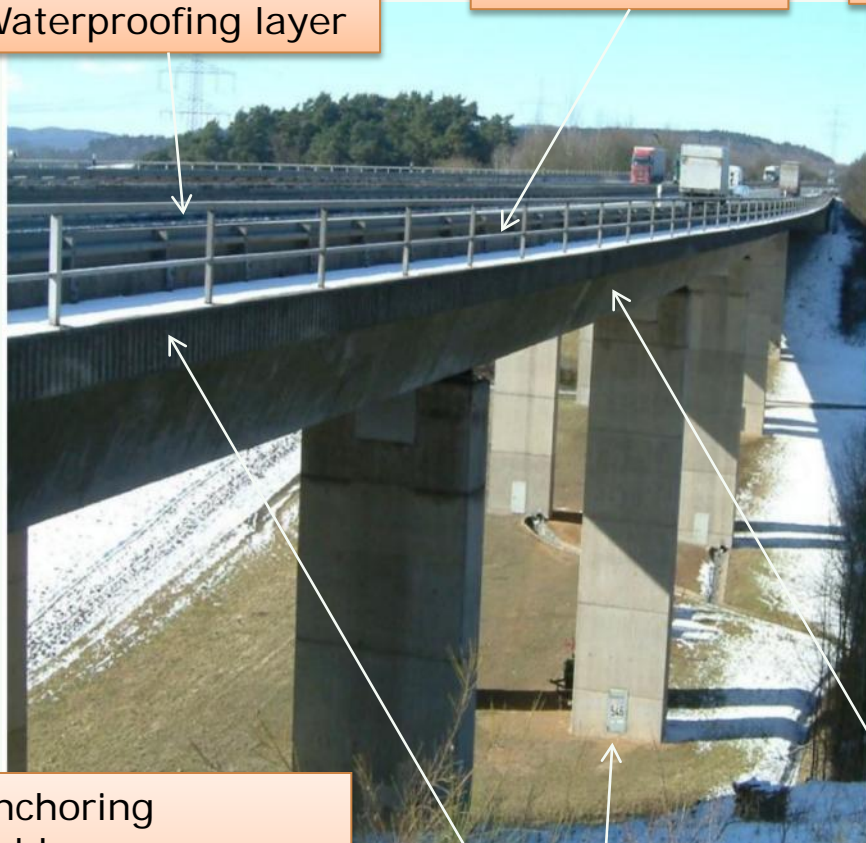
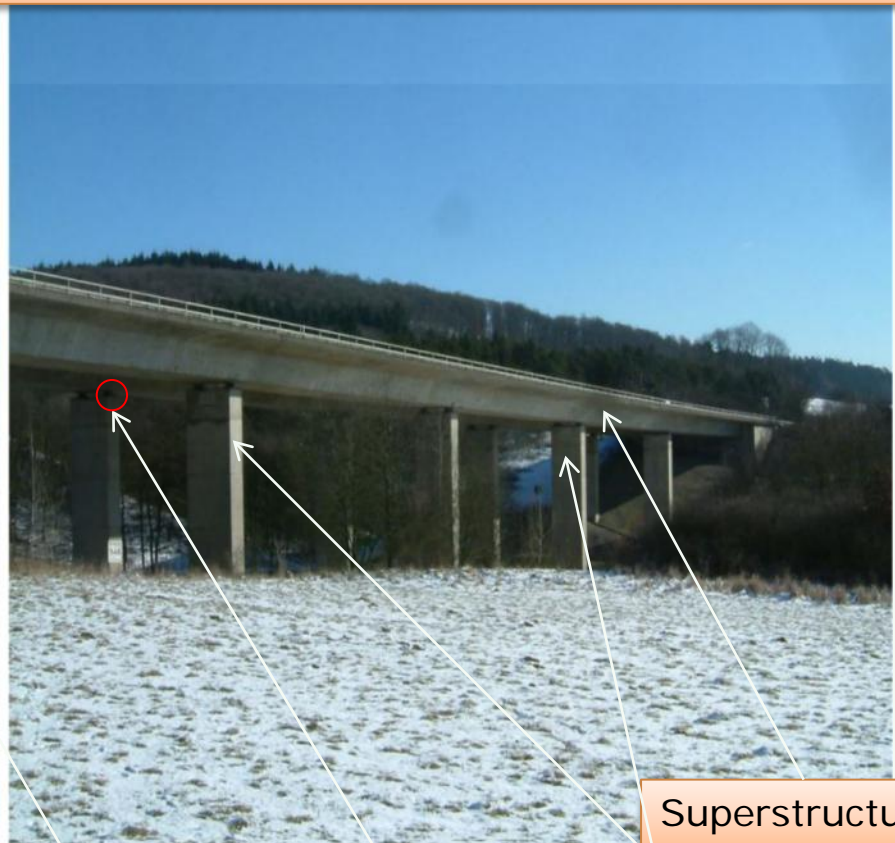
Safety barriers

13 structural components

- Anchoring
- Cables
- Joints
- Others

Caps

Foundation

Stat. System / Tragfähigkeit	Brückenseile, -kabel	Gestaltung	Felder / Stützungen
	Fahrbahnübergangskonstrukt.	Leitungen	
	Abdichtungen	Verfüllungen Risse	
Gründungen	Kappen	Betonersatzsysteme	
Vorspannungen	Schutzeinrichtungen	OS-System Beton	
Erd- und Felsanker	Ausstattungen	RHDB (Dünnbeläge)

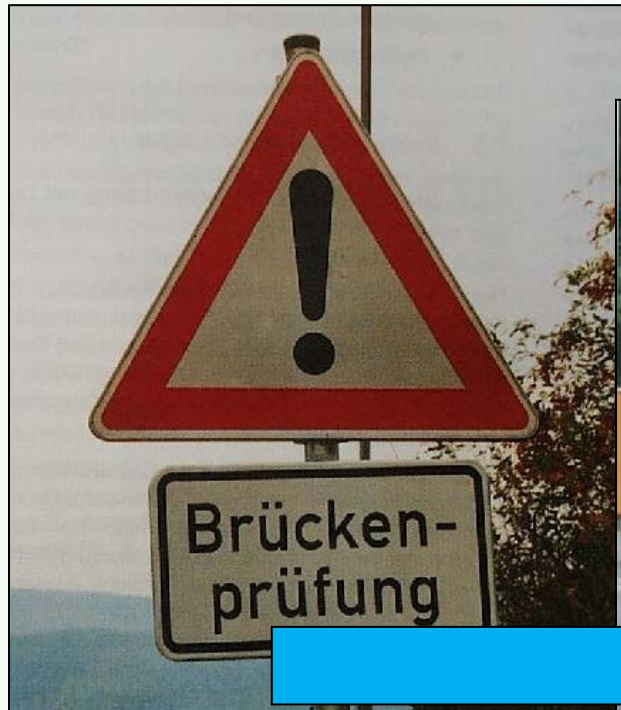
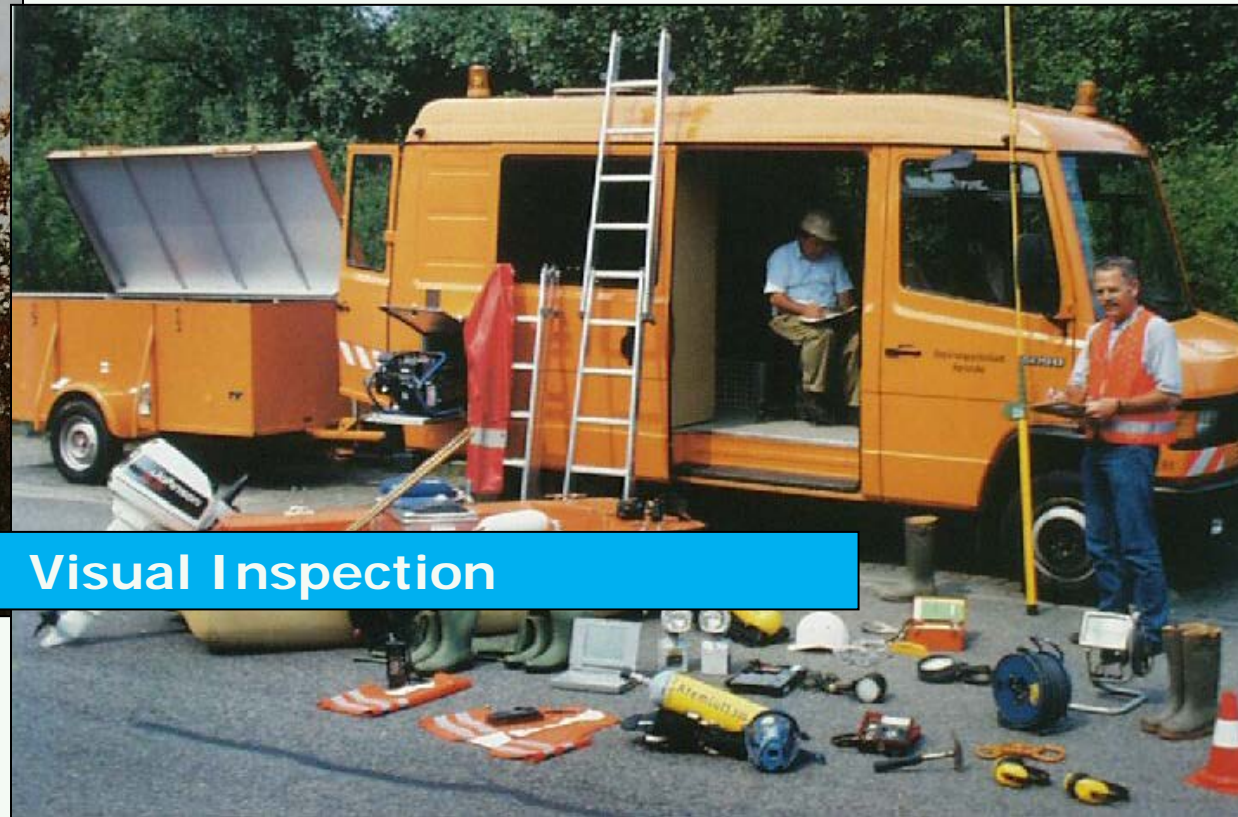
# Bridge Inspection – DIN 1076

- **Major Inspection**  
Hands on visual inspection of all parts of a structure by engineers, every 6 years. Damage and condition assessment according to RI-EBW-PRÜF. First major inspection before the structure is opened to traffic, second major inspection before the end of the guarantee period

- **Minor Inspection**  
Hands on visual inspection by engineers every 3 years after major inspection, verification of major inspection results
- **Ad-hoc Inspection**  
Engineers obtain in-depth view of particular damages or deterioration process (accidents, flooding, ...)

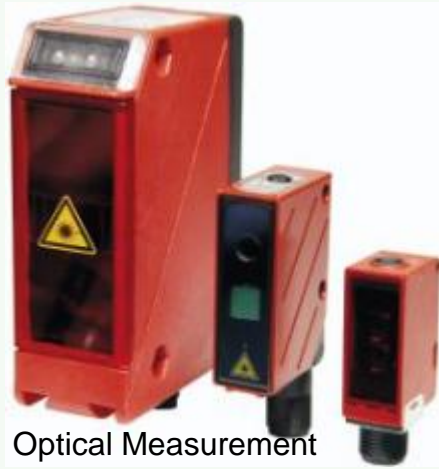
Optical Measurement

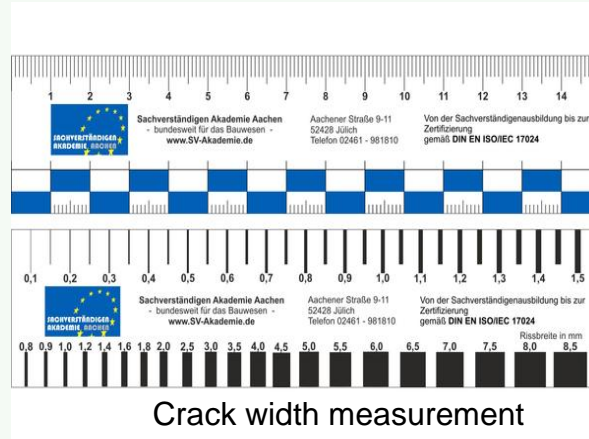
Crack width measurement

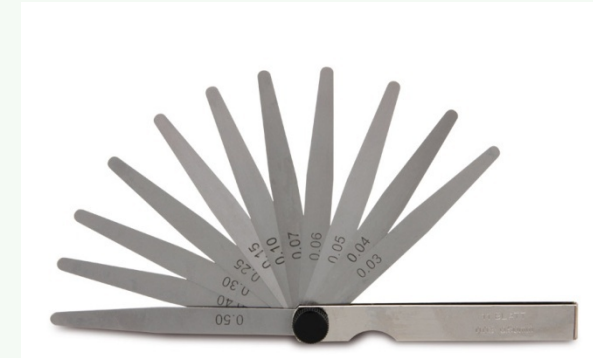
Crack width measurement

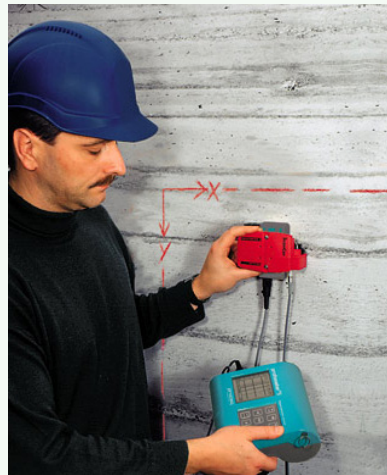
Concrete cover measurement

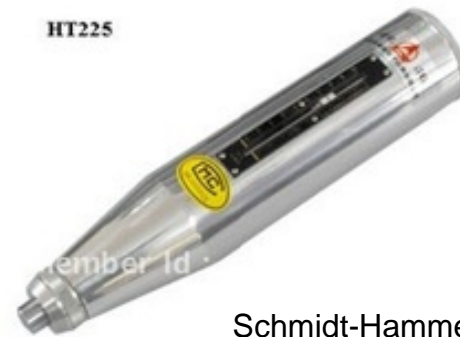
Schmidt-Hammer

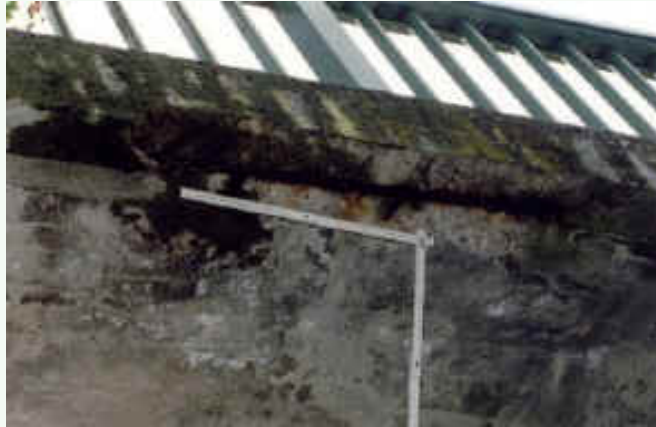
Steel corrosion of the bridge cap (deicing salt, sea water environment)

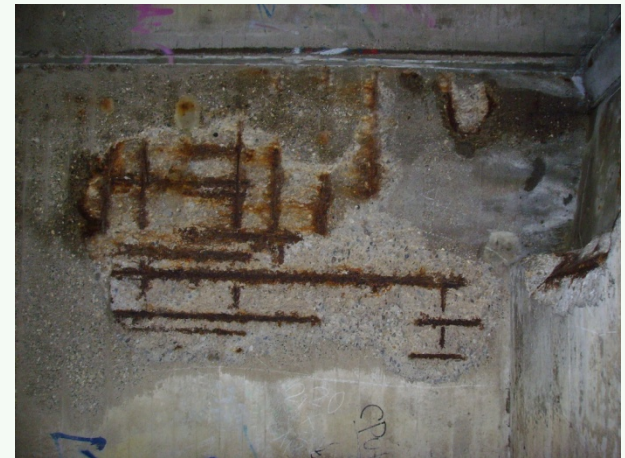
Corrosion due to less concrete cover

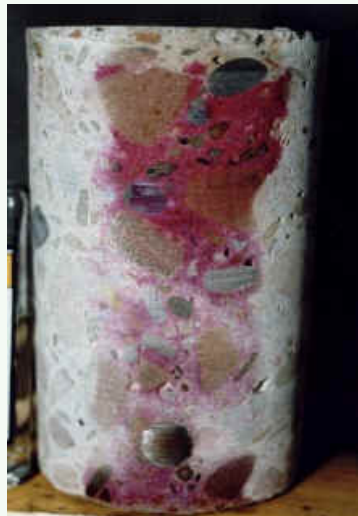
Determination of carbonization depth

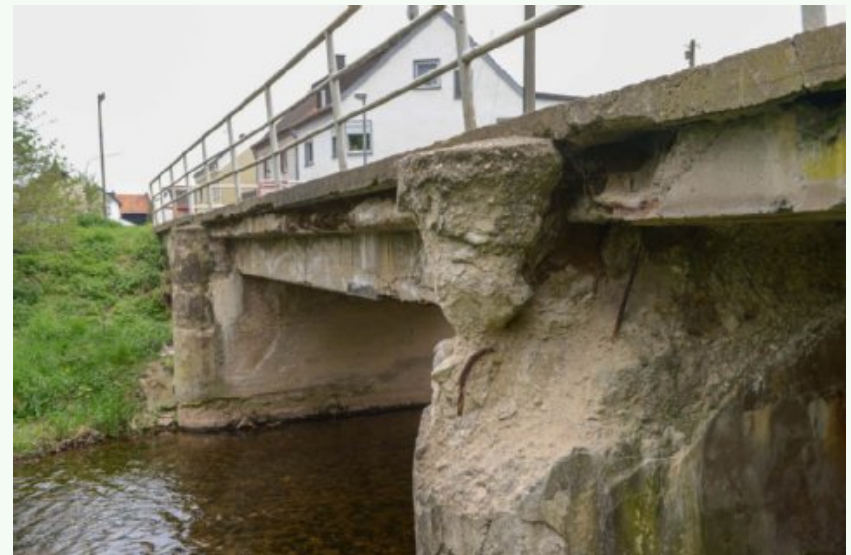
Concrete flaking

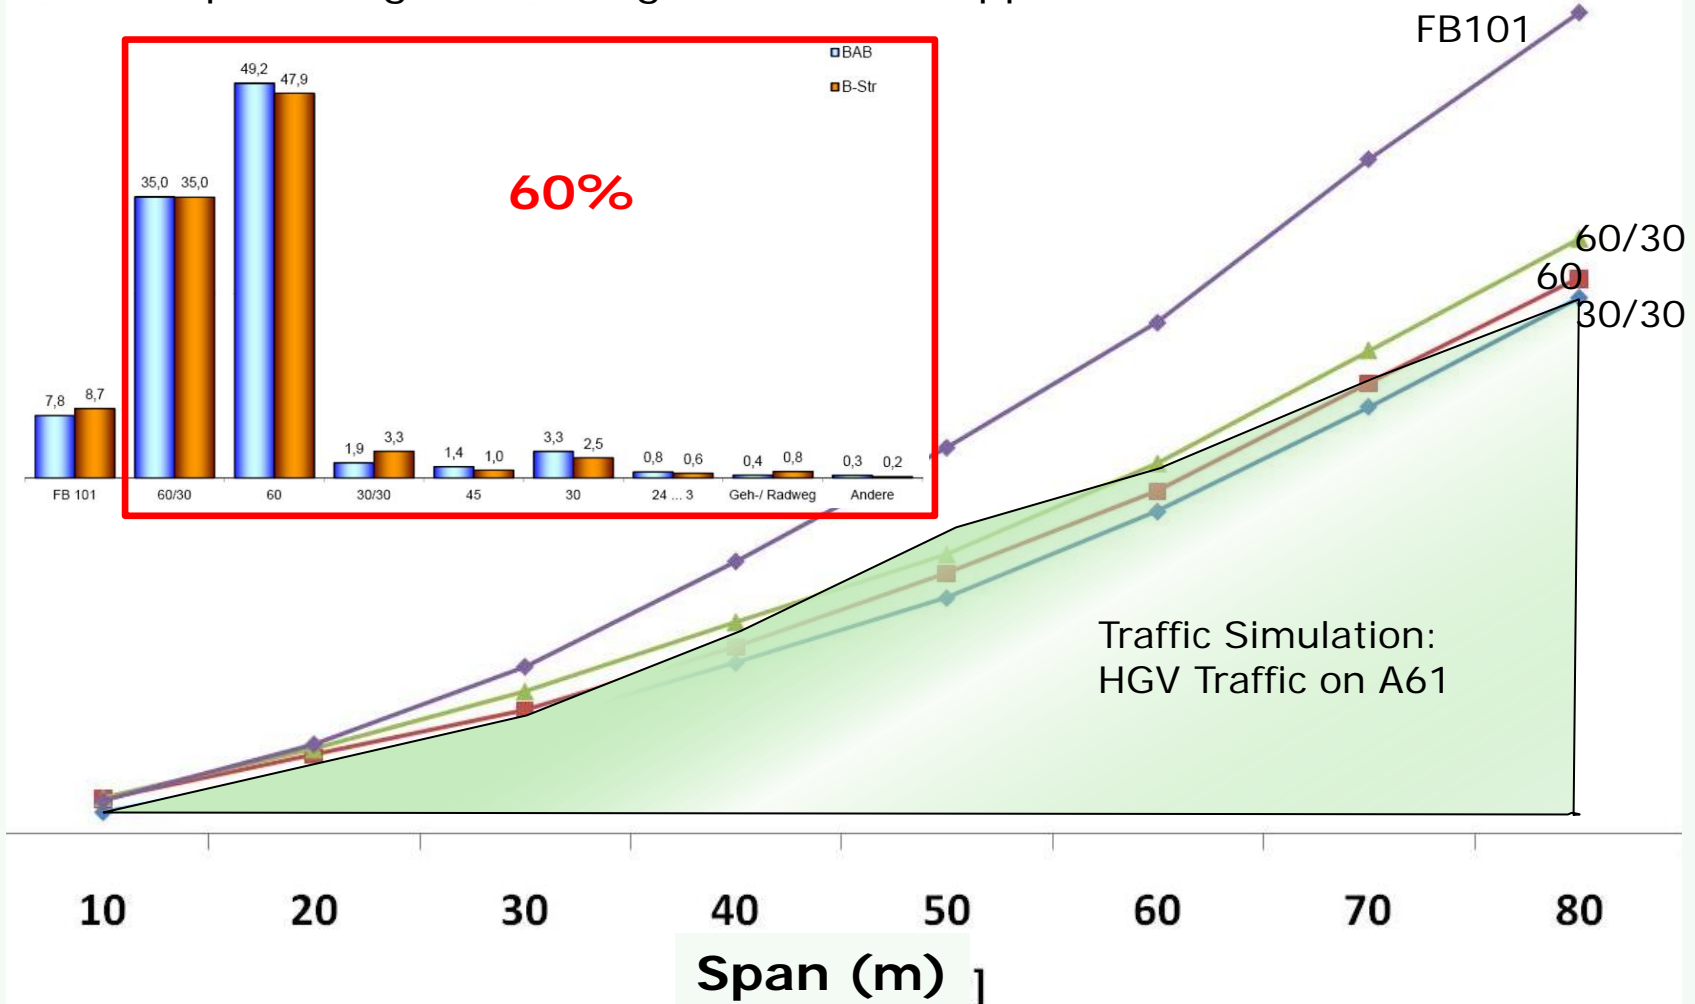
# Traffic Simulation

Two span bridge – bending moment at support

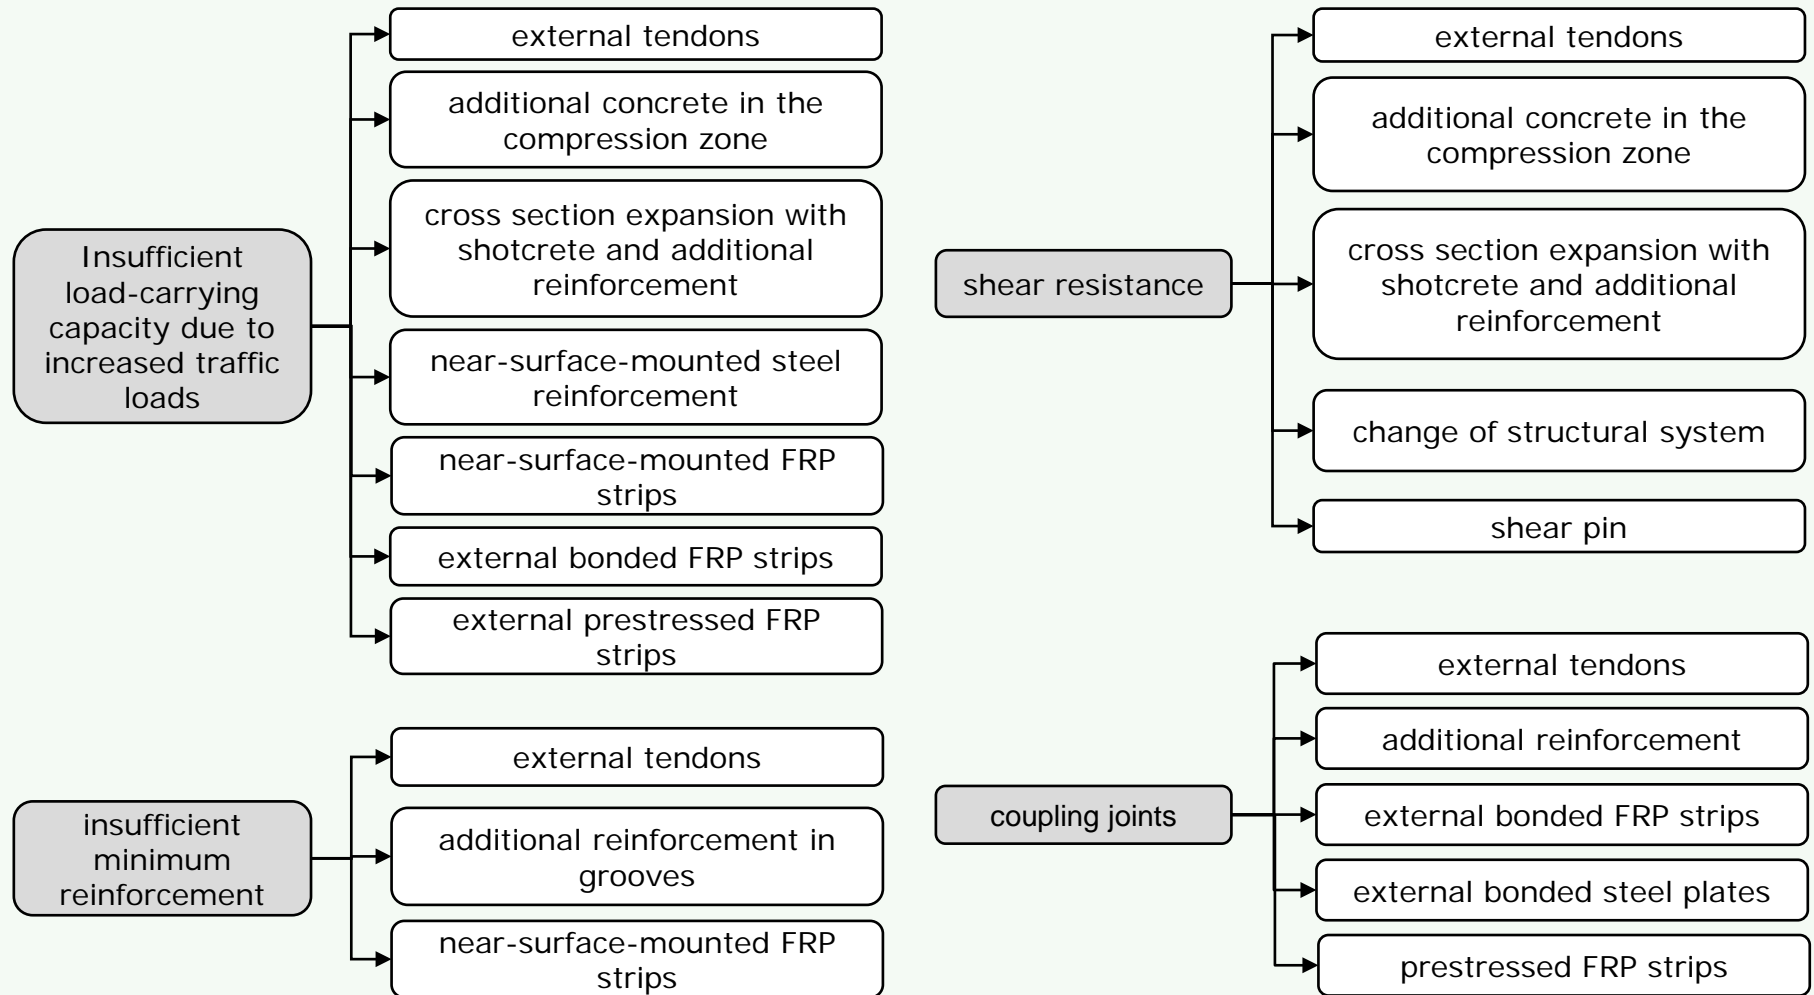
# Retrofitting Methods for Concrete Bridges

Source: Sachstand Verstärkungsverfahren – Verstärken von Betonbrücken im Bestand, Bericht der Bundesanstalt für Straßenwesen, Heft B 75

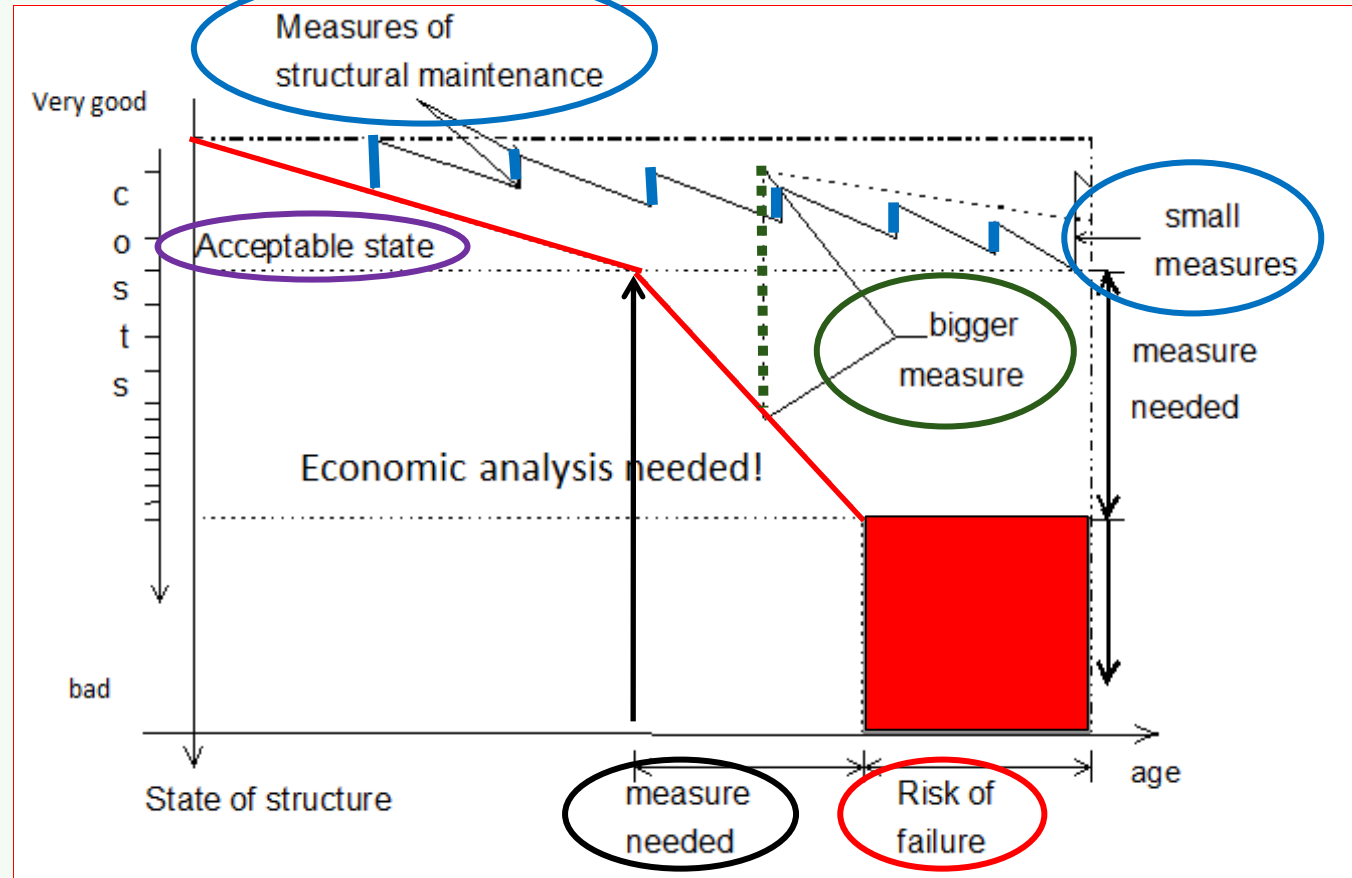
# Maintenance Strategies

- Actual condition of the structure
- Prediction of further deterioration
- Effect of different maintenance measures

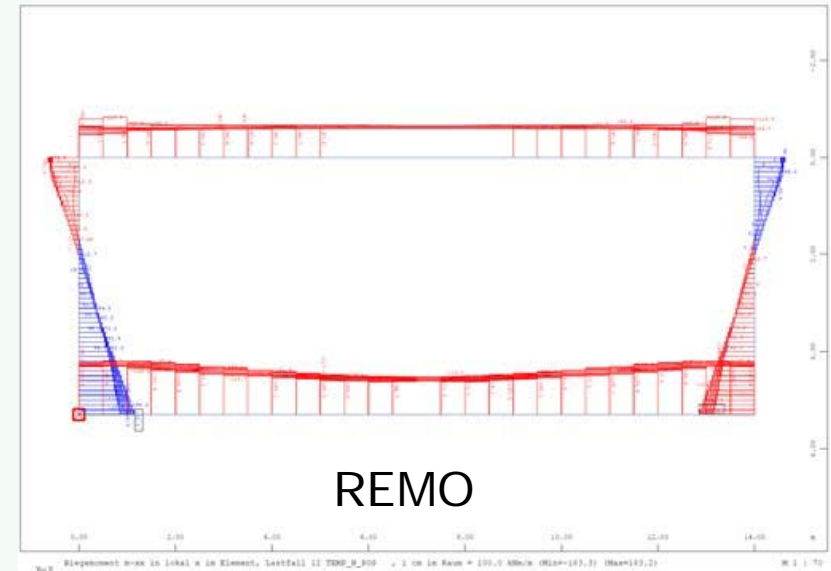
## Extreme Weather – Example Concrete Frame

Load case: positive temperature gradient (DIN FB 101-2009) and relevant characteristic values from regional climate projection (REMO)

Temperature (constant and linear)

- Increase of the max. bending moment and the edge stresses by 7.5% compared to DIN FB 101
- Increase of max. bending moment and edge stress by 24% compared to DIN 1072:1967 (durability)

- Effects of second order for high bridges
- Reductions according to DIN FB as well as National Annexes have to be reassessed
- Bridges designed according to DIN 1072, 1967 have significant deficits in all respects

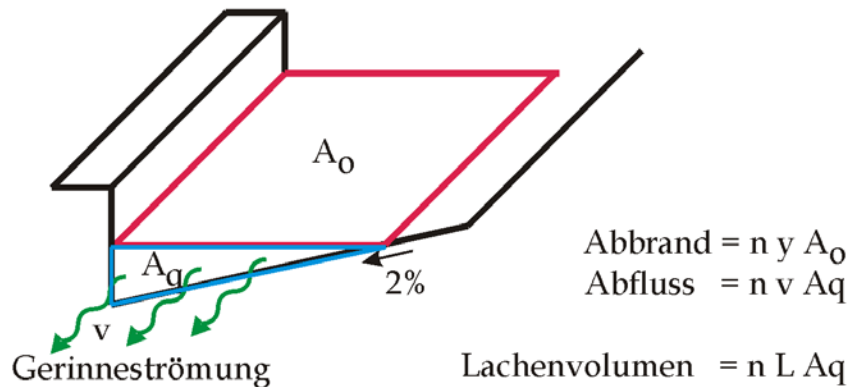
## Fires on Bridges (suspended deck arch bridge)

# Tank Truck (28t Petrol)

Detail nicht maßstäblich

Bezeichnung	Burning liquid [kg] an [%]	Drained liquid [kg] an [%]
Kuppe300G1	1.400 / 5%	26.600 / 95%
Kuppe 300G2	1.700 / 6%	26.300 / 94%
Kuppe20,6G1	5.000 / 18%	23.000 / 82%
Kuppe20,6G2	6.500 / 23%	21.500 / 77%
Neigung300G1	2.000 / 7%	26.000 / 93%
Neigung300G2	2.500 / 9%	25.500 / 91%
Neigung20,6G1	6.500 / 23%	21.500 / 77%
Neigung20,6G2	7.800 / 28%	20.200 / 72%

$A_q$  Drainage Cross Section

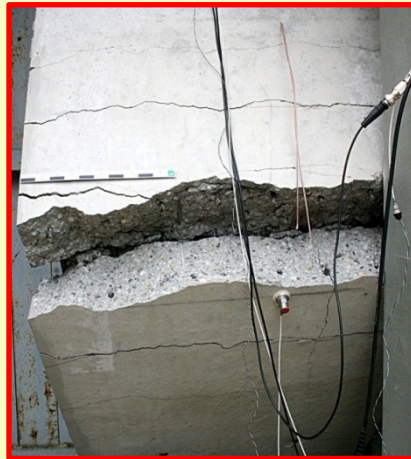
## High Speed dynamic Effects - Shield Tunnel under Blast Exposure

Global Failure

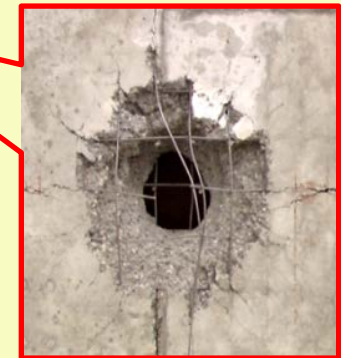
Local Failures

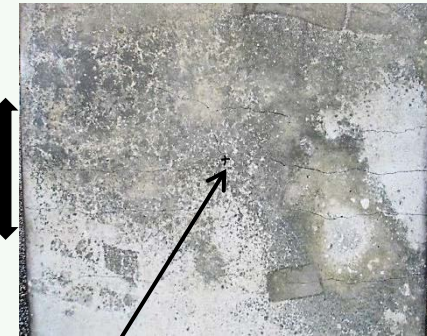
## Tunnel model tests – Numerical simulations

Maximum damage, Deformation in slab center
